Manhole Inspection Summary

Manhole # S19M__009MH

Insp Date: **3/25/08 12:15 PM**

Location Address: **447 ashton st**

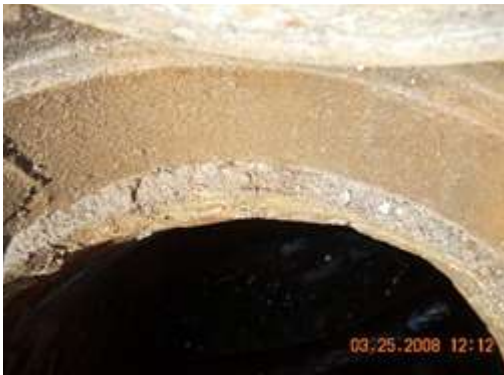
Defect 1

Frame Offset: **2** (in.) Condition: ☒ Sound ☐ Cracked ☐ Leaks

frame offset

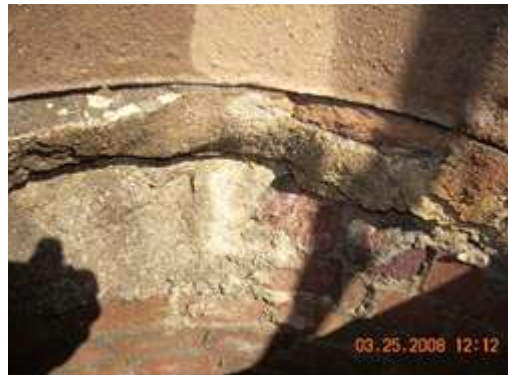
Defect 3

Condition: ☐ Sound ☐ Cracked ☐ Root Intrusion ☐ Loose Brick ☒ **Deteriorated**

deteriorated corbel

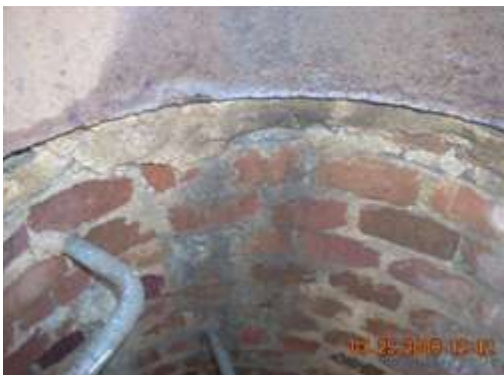
Defect 2

Infiltration: ☐ None ☒ **Joint** ☐ Cracks ☐ Mortar ☐ Roots ☐ Wall

infiltration at the corbel joint

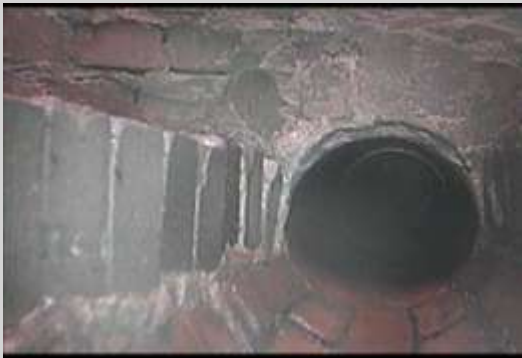
12 O'Clock Outflow

8 in. Circular Gravity Sewer
Pipe Out @ 12 O'Clock

Pipe Height: **8.4** (in.) Rod and Bar (Angled)
Pipe Material: **Clay** ☐ Pipe Lined
Invert Depth: **8.50** (ft.) Flow Characteristics: **Slow**
Deposits: ☒ None ☐ Mud ☐ Sludge ☐ **Debris** ☐ Grease
Silt Depth: **0** (in.) Deposits Extent:
Infiltration: **None** Pipe Seal Cond: **Broken**

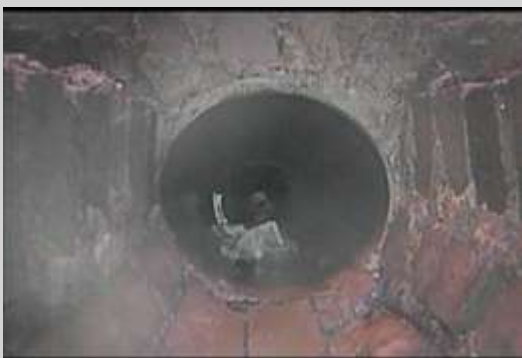
5 O'Clock Inflow

8 in. Circular Gravity Sewer
Pipe In @ 5 O'Clock

Pipe Height: **8.4** (in.) Rod and Bar (Angled)
Pipe Material: **Clay** ☐ Pipe Lined
Invert Depth: **8.39** (ft.) Flow Characteristics: **Slow**
Deposits: ☐ None ☐ Mud ☐ Sludge ☒ **Debris** ☐ Grease
Silt Depth: **1** (in.) Deposits Extent: **Light**
Infiltration: **None** Pipe Seal Cond: **Sound**
